# ANDROSCOGGIN LAKE

## Watershed-Based Protection Plan

WAYNE, LEEDS, AND MONMOUTH, ME

# ANDROSCOGGIN LAKE WATERSHED SURVEY 2022

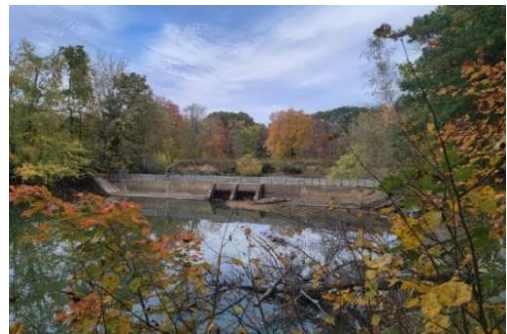
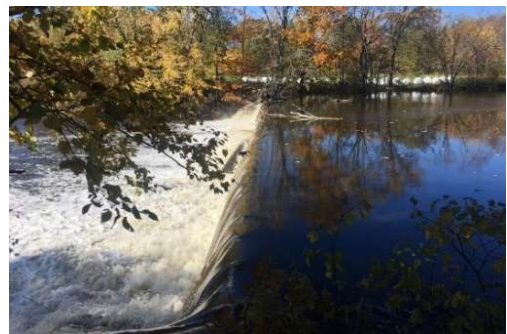
*Dead River PCF in Oct. '21 (top) and flow reversal in Oct. '22 (bottom) after heavy rains caused the Androscoggin River to rise ~16 ft.*

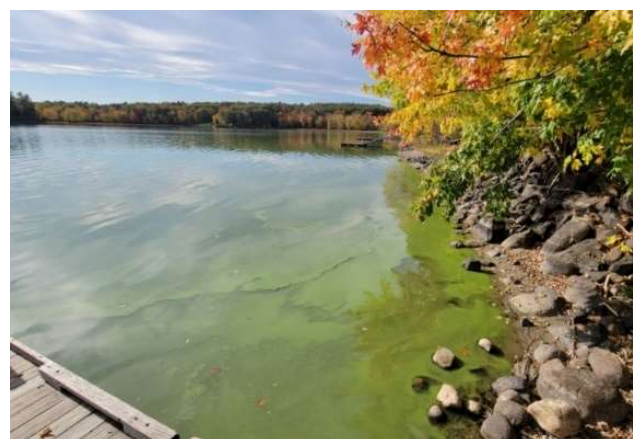
Shoreline scum formation at the public boat launch on Route 133 in Wayne – October 2021.

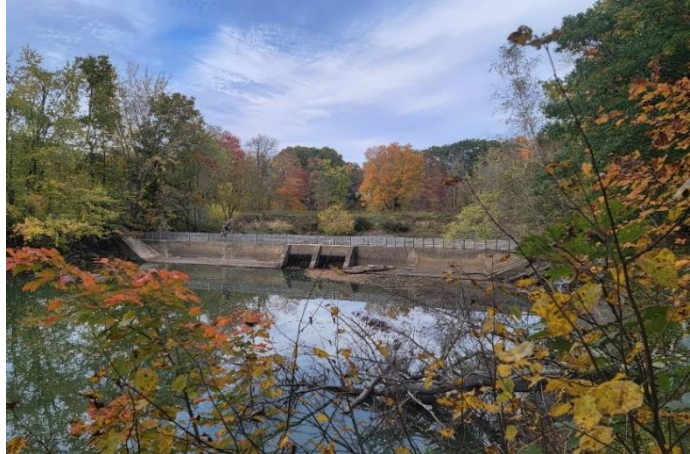
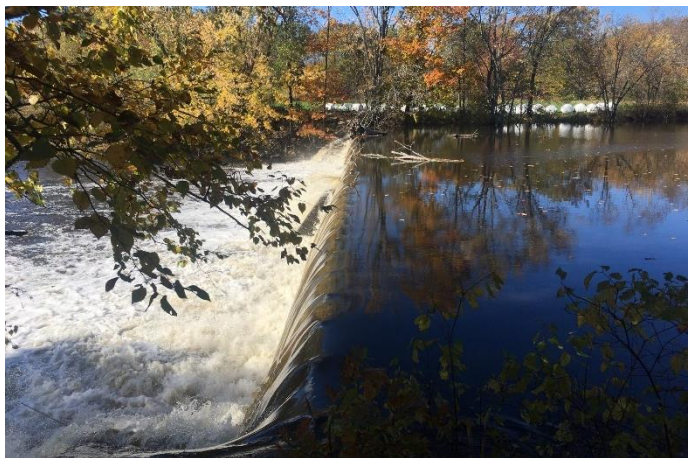
*The Dead River pollution control facility in October 2021 ( top) and flow reversal in October 2022 after heavy rains caused the Androscoggin River to rise ~16 feet (bottom).*

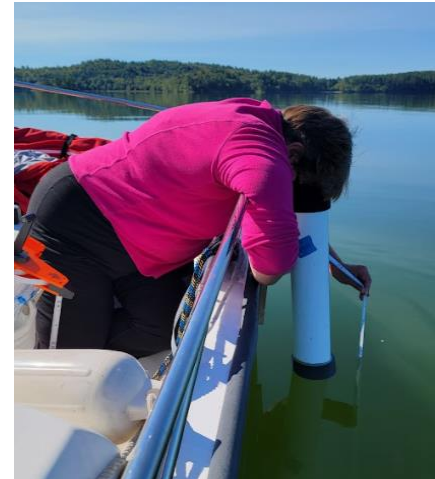
*ALIC Volunteer monitor, Patt Koscinski, collects clarity data using a Secchi disk and scope in September, 2021.*

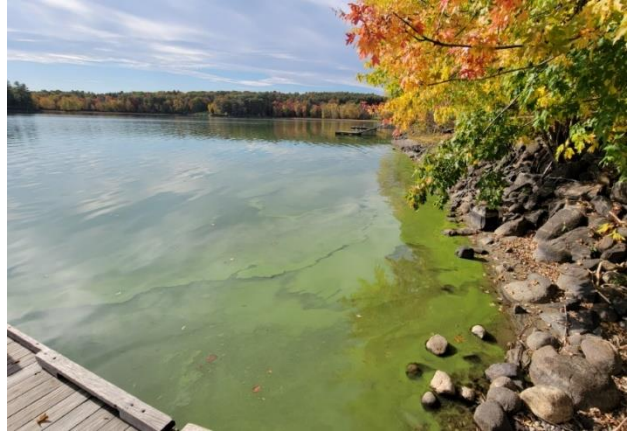
*Shoreline scum formation at the public boat launch on Route 133 in Wayne – October 13, 2021.*

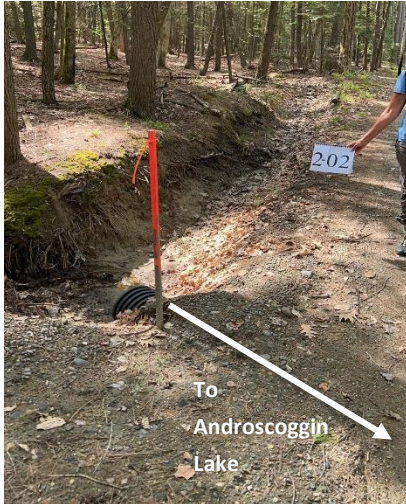
*Ditch, culvert, and road surface erosion identified on a private gravel road that drains to Androscoggin Lake.*

- ✓ Armor/vegetate culvert inlet/outlet
- ✓ Replace and enlarge culvert
- ✓ Resurface w/ correct crushed gravel
- ✓ Remove winter sand
- ✓ Crown road, stabilize shoulders, and install ditch to manage road runoff.
- ✓ Install ditch turnouts or check dams
- ✓ Install plunge pool/basins to settle out sediment in road runoff.

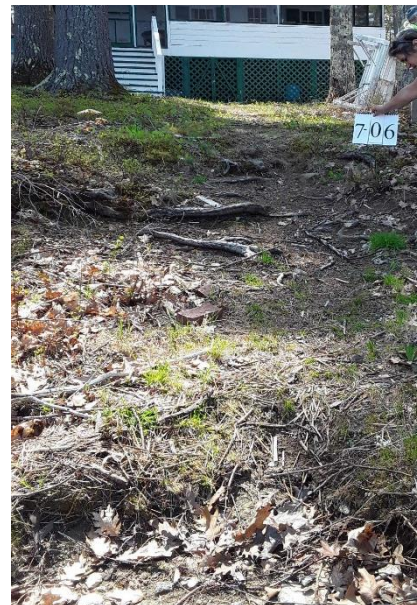
*Surface erosion on a pathway leading to Androscoggin Lake.*

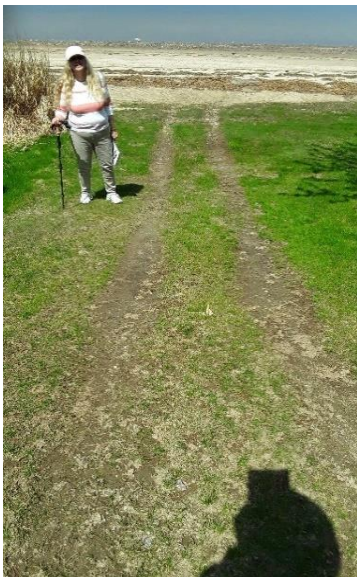
*Example beach/boat access site identified in Sector 3.*

- ✓ Define and narrow access opening
- ✓ Establish shoreline buffer vegetation
- ✓ Cover eroding surfaces with ECM or crushed stone
- ✓ Install runoff diverter across boat or beach access to prevent runoff from entering the lake.

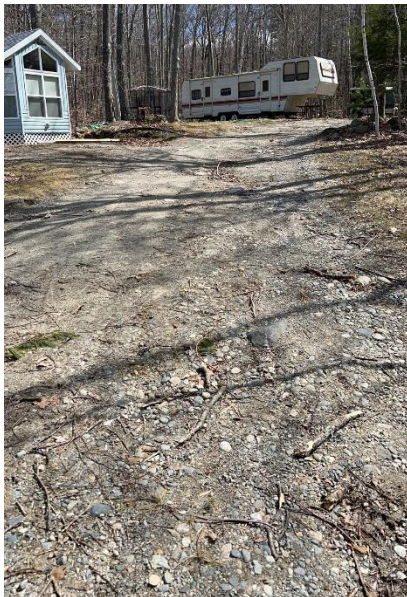
*Example commercial property site, JS-07, identified in Sector 4*

- ✓ Define and narrow lake access openings
- ✓ Establish shoreline buffer vegetation
- ✓ Cover eroding surfaces with ECM or crushed stone, or revegetate
- ✓ Resurface eroding road gravel and reshape to a crown
- ✓ Redirect runoff on road or pathways into stable vegetation.

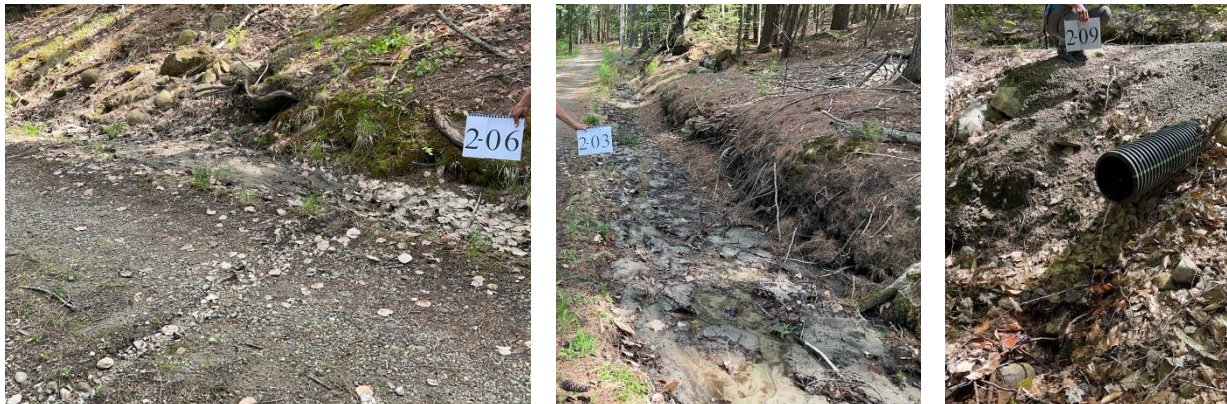
*Erosion sites identified on Dole's Beach Road / The Boulevard in Sector 2. Runoff over-topping the road (Site 2-06) and eroding a channel in the road surface, and overwhelmed ditch full of sediment that drains to Androscoggin Lake (Site 2-03), and an unstable culvert outlet (Site 2-09).*

Recommendations: Clean out, improve, and stabilize ditches, replace undersized culverts and armor or vegetate inlet/outlet. Plunge pools at culvert outlets will capture sediment from ditch and road and prevent it from entering the lake. New/correct gravel surface material and crown needed.

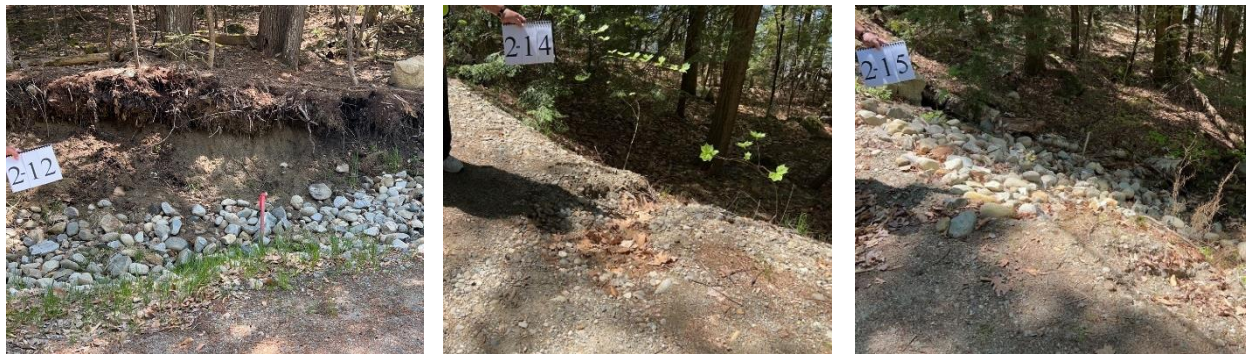
*Private road sites 2-12, 2-14, and 2-15 documented on Holman Terrace in Sector 2.*

Recommendations: Improve ditch and stabilize bank slopes with rock and erosion control mulch, clean out or replace undersized/clogged culvert, and vegetate road shoulders to stabilize. Plunge pools at culvert outlets will capture sediment from the ditch and prevent it from entering the lake. New/correct gravel surface material and crown needed.

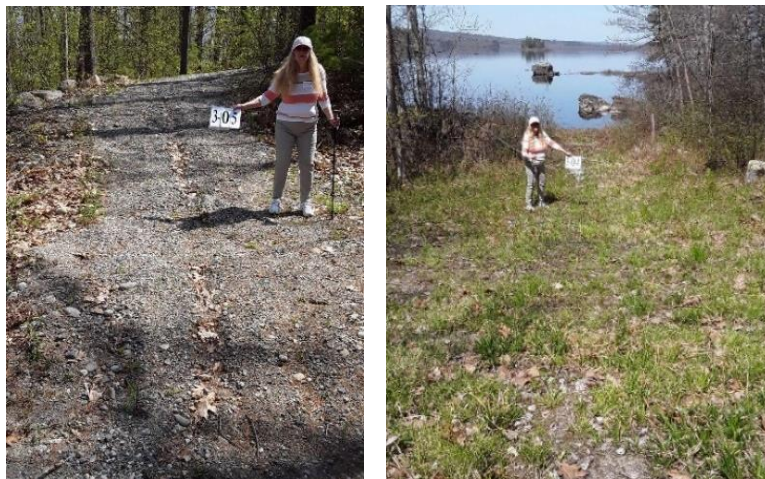
*Site 3-05 (left) and site 3-04 (right) identified on Moose Run Road in Sector 3.*

Recommendations: Build up road with new/correct surface gravel and install an in-road runoff diversion to move stormwater off the road surface and prevent erosion as it flows downhill.

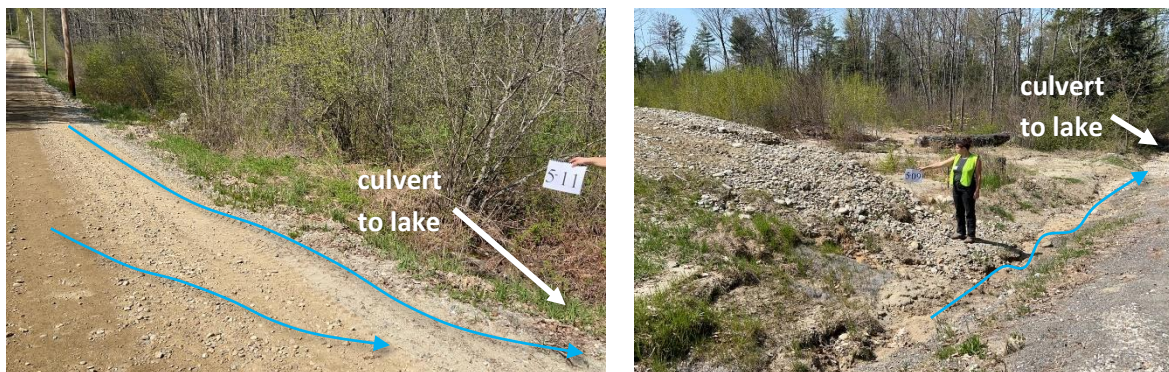
*Site 5-11 (left) and site 5-09 (right) identified on Bishop Hill and Bernie Hartford Roads in Sector 5.*

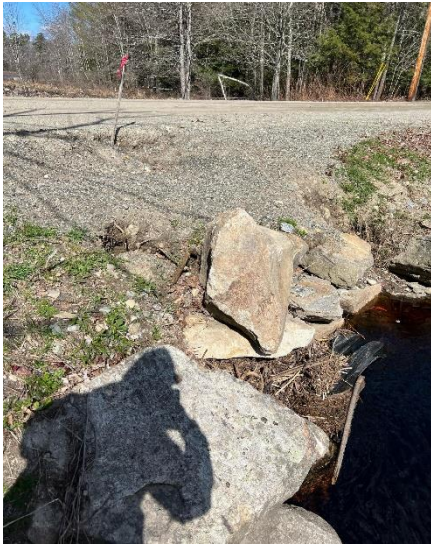
*Site 4-01 in Wilson Pond Road in Monmouth – crushed culvert inlet.*

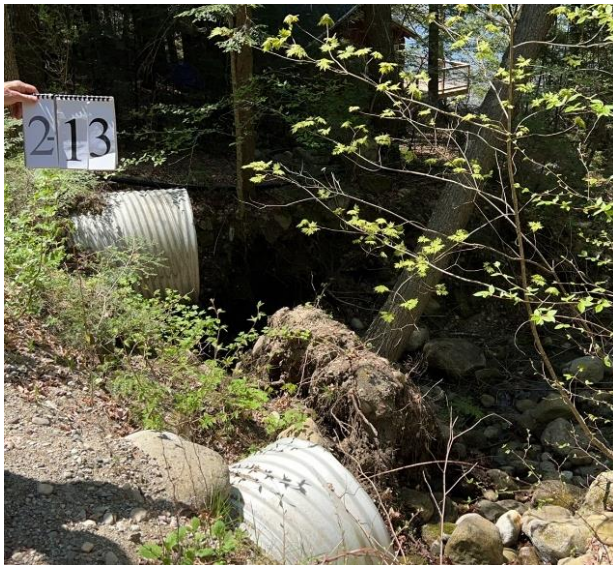
*Bank failure at a culvert outlet (site 2-13) on Holman Terrace in Sector 2.*

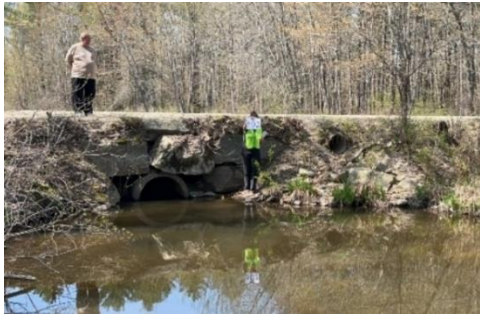
Site Number(s): 5-02 and 5-05

*Site 5-02 (top) and site -02 (bottom) identified on Bishop Hill Road in Sector 5.*

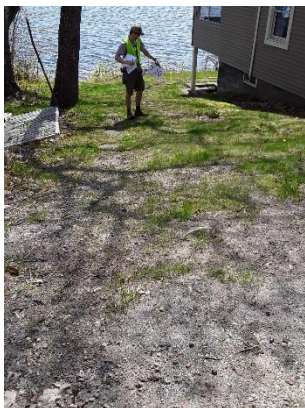
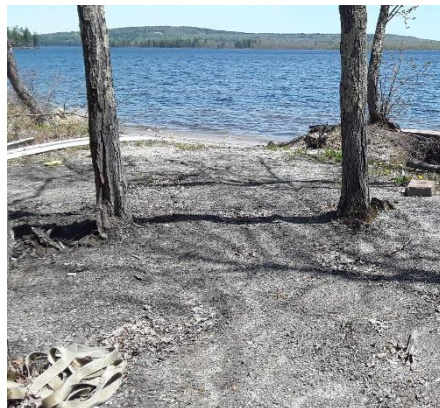
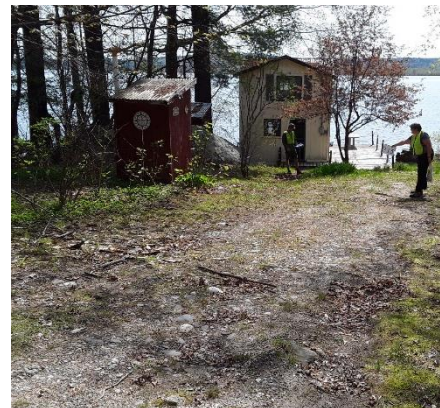
*Example sites identified on Lakeshore Drive in Sector 7: Site 7-20 (left) medium-impact residential, site 7-28 (middle) high-impact beach access erosion, and site 7-15 (right) high-impact driveway erosion.*

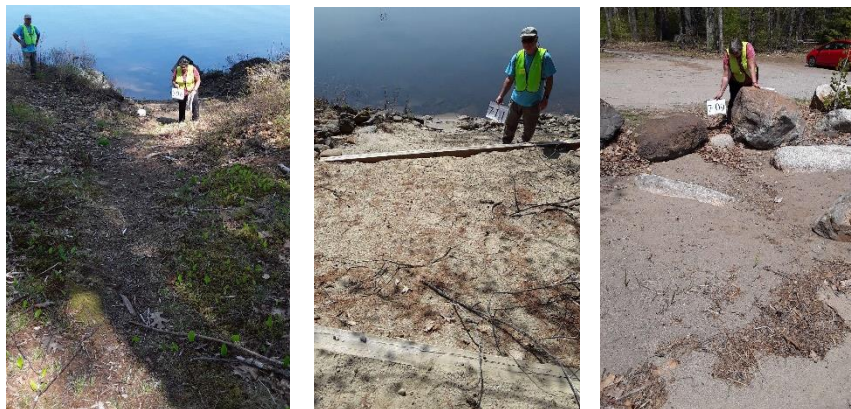
*Example sites identified in the Stinchfield Beach neighborhood in Sector 7: Site 7-06 (left) erosion on a shorefront pathway, site 7-11 (middle) unstable soils on a steep slope, and site 7-09 (right) runoff from a town parking lot is creating a channel with flow to Androscoggin Lake.*

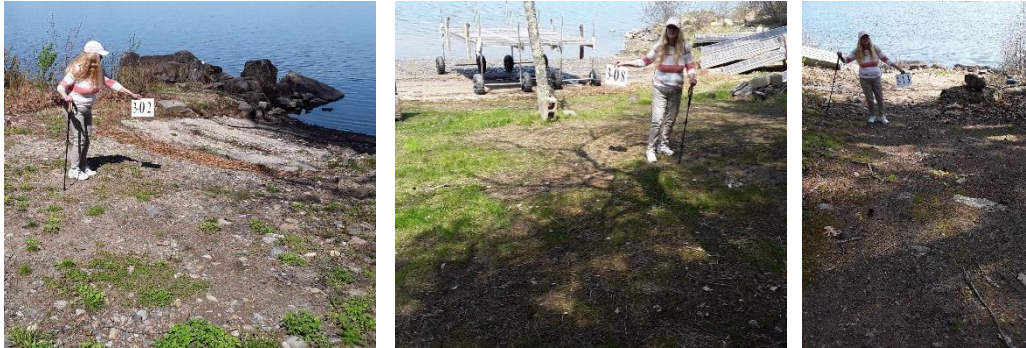
*Examples of sites identified in Sector 3: Site 3-02 (left) erosion on a beach access, site 3-08 (middle) bare soils and sheet erosion over a lawn without a shoreline buffer, and site 3-13 (right) erosion documented on a shorefront path.*

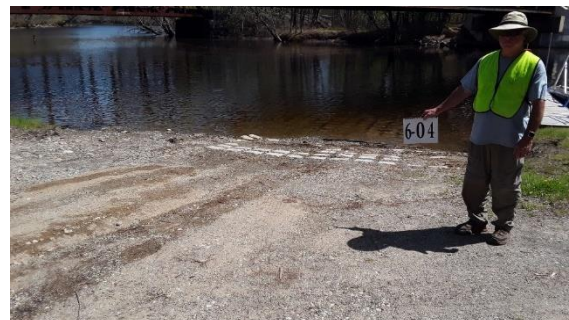
*Erosion documented at a commercial boat launch in Sector 6 (site 6-04).*

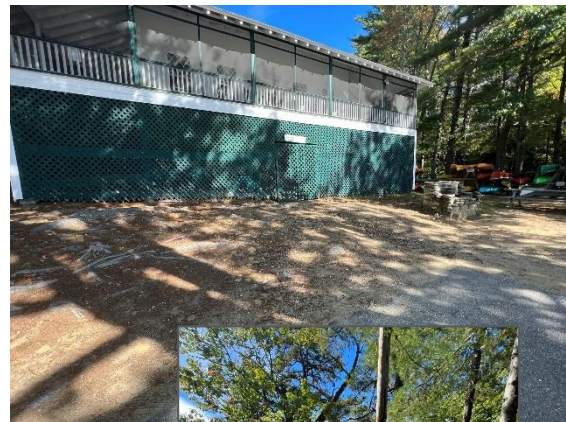
### Site 9-14 (Commercial boat launch, beach, and adjacent recreation areas)

Documented NPS Problem: Stormwater runoff from Lake Street and adjacent land uses is flowing unimpeded down boat launch and into Androscoggin Lake. Bare and eroding soils documented in common/recreational spaces (fire pit/picnic area, boat storage area, and swimming beach access). Erosion at building driplines resulting from roof runoff. Lack of adequate vegetative buffer.

Recommendations: Stormwater runoff diversions needed near parking lot and Lake Street to prevent runoff from flowing down boat launch and into the lake untreated. Define and stabilize common areas with erosion control mulch (ECM) or crushed stone, and add vegetation around edge to define, Capture and infiltrate roof runoff by installing a dripline trench or rain gardens. Improve stand of vegetation between developed spaces and the beach/lake.

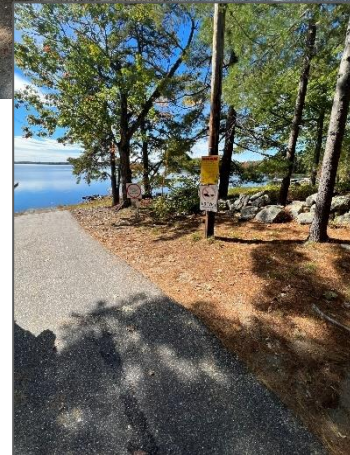
*Erosion at roof driplines and adjacent common spaces (top) and boat launch (bottom) documented at site 9-14 in Wayne*

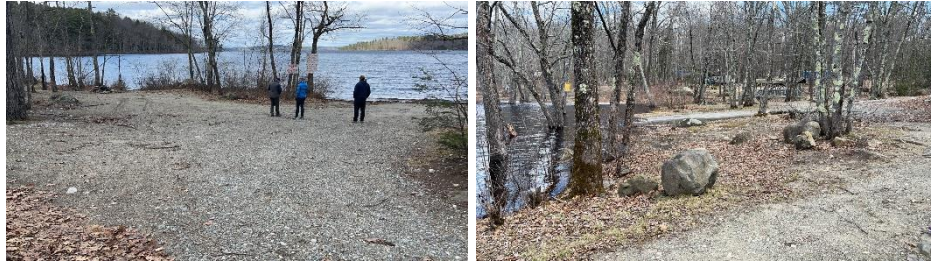
*Site JS-01 (left, beach access) and site JS-02 (right, boat launch) at a commercial property in*

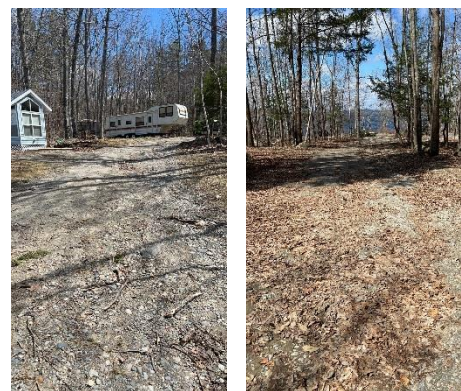
*Site JS-7 (left) and site JS-8 (right) – documented erosion sites flowing to lake via Sites JS-5 and JS-6.*

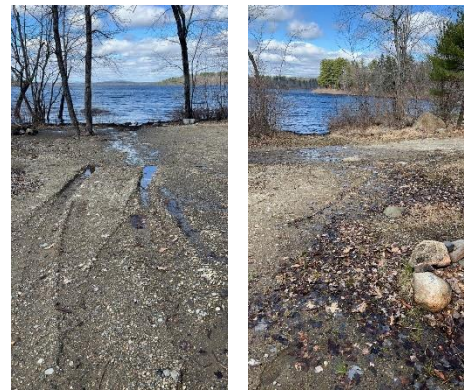
*Site JS-5 (left) and site JS-6 (right) – stormwater runoff entry points.*
