# 2023 POCASSET LAKE WATERSHED SURVEY

On September 28<sup>th</sup>, 2023, 30 Mile River Watershed Association (30 Mile), with the support of its partners and local volunteers, conducted a survey of the Pocasset Lake watershed. The purpose of the survey was to protect and improve water quality in the lake by identifying sources of soil erosion and polluted runoff that are now, or could in the future, pose a risk to water quality, and recommend solutions to correct the problems identified.

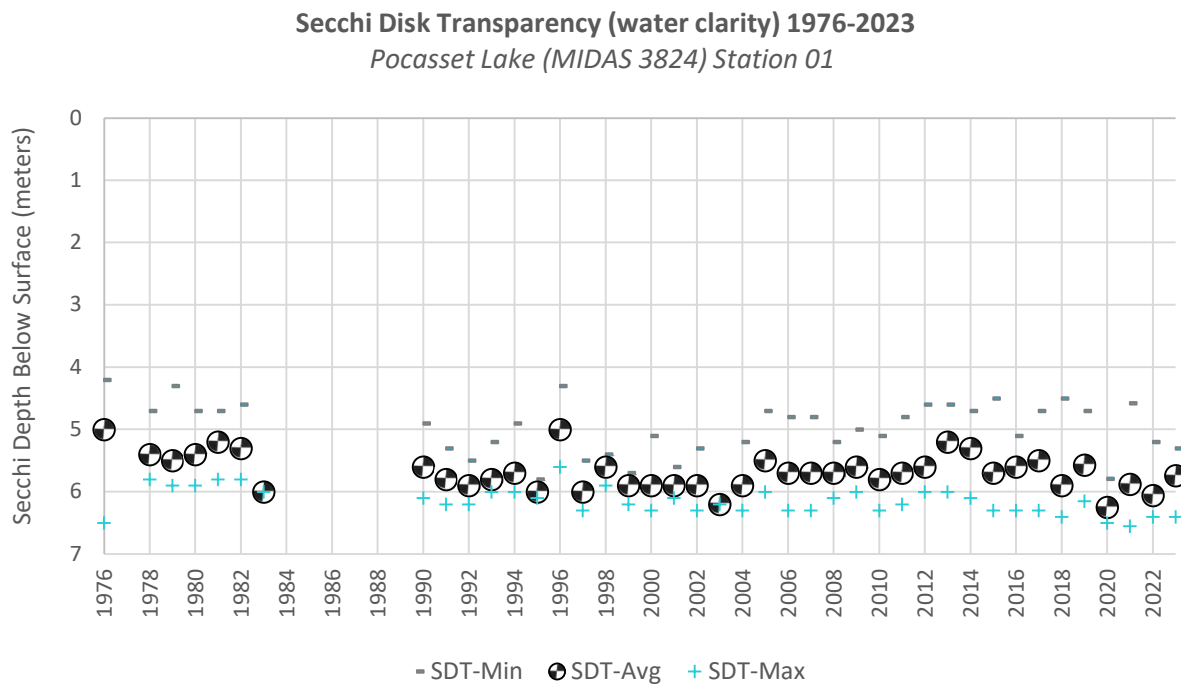
Pocasset Lake's water clarity has been somewhat consistent over the long-time monitoring record. This is in part due to the lake's high flushing rate of nearly 8.5 flushes per year. With this, relatively low chlorophyll (the pigment found in algae) concentrations have been observed in Pocasset Lake, and Secchi disk readings have reached the bottom of the lake during 28 years throughout the 47-year monitoring record.

*Figure 2. Secchi Disk Transparency (Water Clarity) in Pocasset Lake, Station 1, 1976-2023*

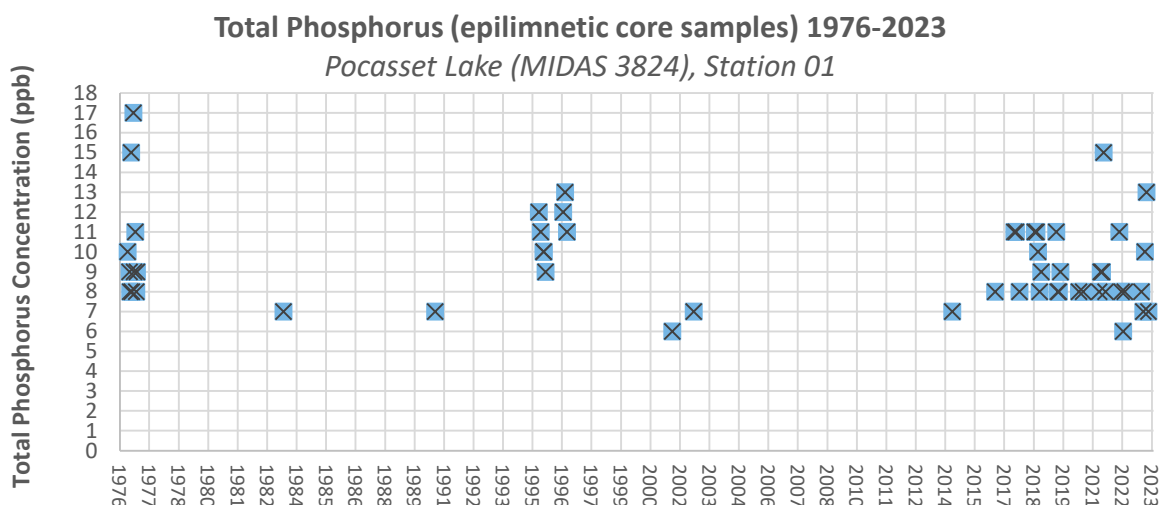
*Figure 3. Total Phosphorus (TP) concentrations from epilimnetic core water samples, Pocasset Lake, 1976-2023*

Historically, phosphorus concentrations (epilimnetic core samples) collected from Pocasset Lake have ranged between 6 ppb (2001 and 2022) and 17 ppb (1976), with a historical average of 9 ppb (Figure 3). Laboratory results for phosphorus samples collected in 2023 ranged from 7 ppb to 13 ppb with an average of 9 ppb.

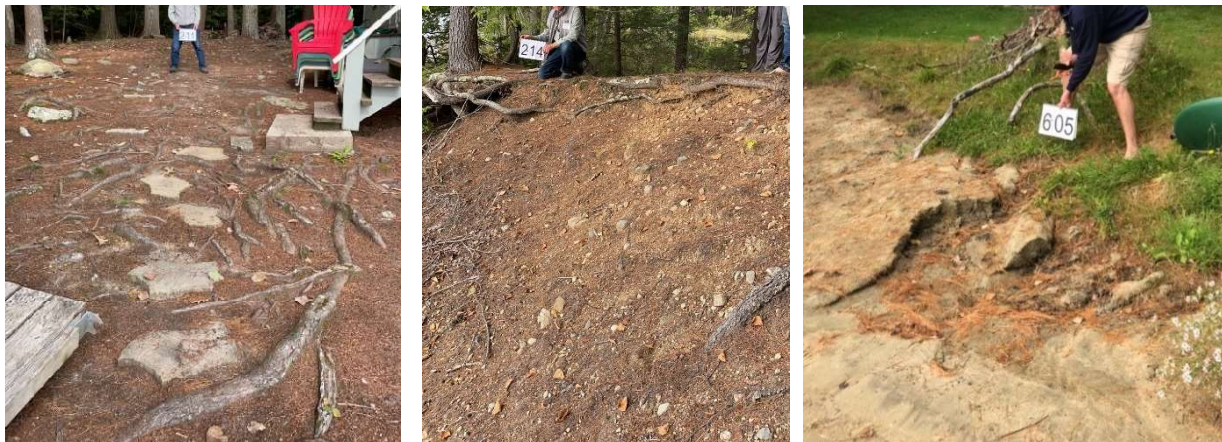
*Surface erosion on a pathway leading to the lake exposes tree roots and bare soil (site 2-11, left). Shoreline bank erosion delivers sediment directly to the lake (site 2-14, center). Runoff from developed areas causes gully erosion on a Pocasset Lake shorefront (site 6-05, right).*

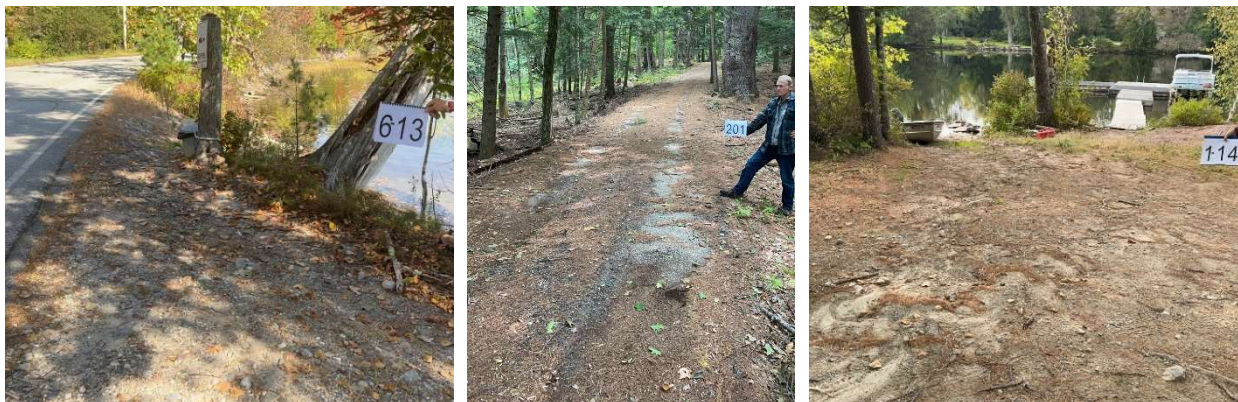
*Road shoulder and surface erosion on a town road at the carry-in launch location on Pond Road (site 6-13, left). Road surface erosion on a private gravel camp road (site 2-01, center). Runoff exiting a driveway causes rill and gully erosion and delivers pollutants directly to the lake via boat and dock access points (site 1-14, right).*

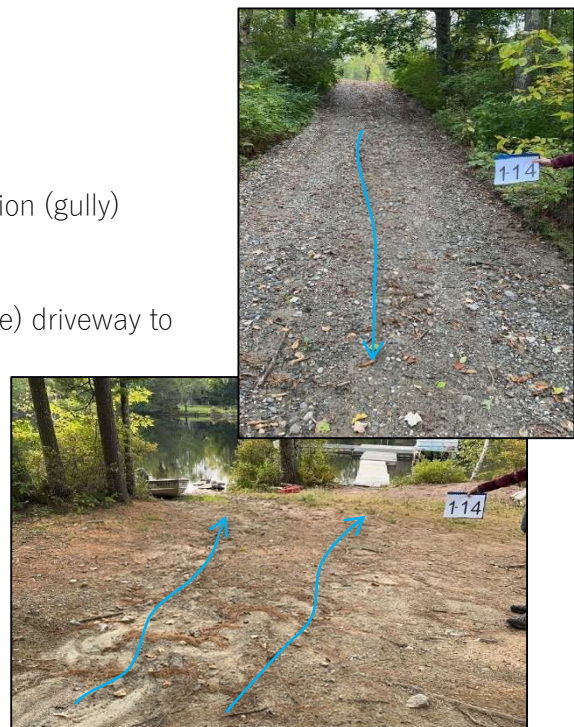
*High impact driveway site 1-14*

Recommendation(s): Reshape (crown or super-elevate) driveway to help shed water into adjacent wooded area.

Depending on winter use, install multiple runoff diverters - rubber razor blades (not recommended on driveways plowed in the winter time) or broad-based dips on driveway and nearing shoreline to break up runoff flow and send it to stable areas away from the lake. Add to shoreline buffer.

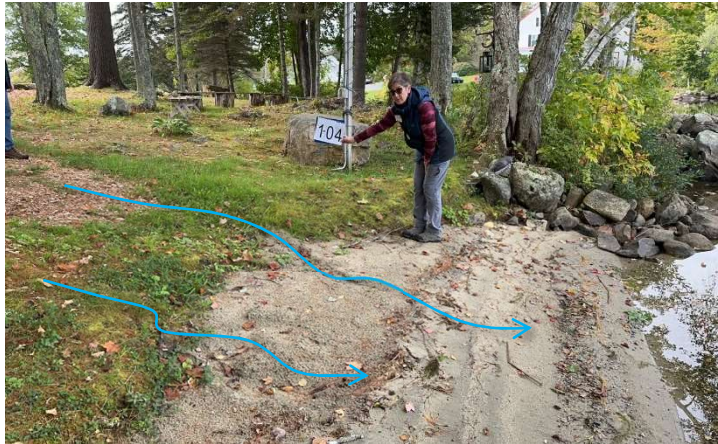
Site Number: 1-04

Problem(s): Surface erosion (gully), lack of vegetation, and inadequate buffer along the shoreline.

Recommendation(s): Establish native shoreline buffer vegetation immediately above the beach area to help keep soil

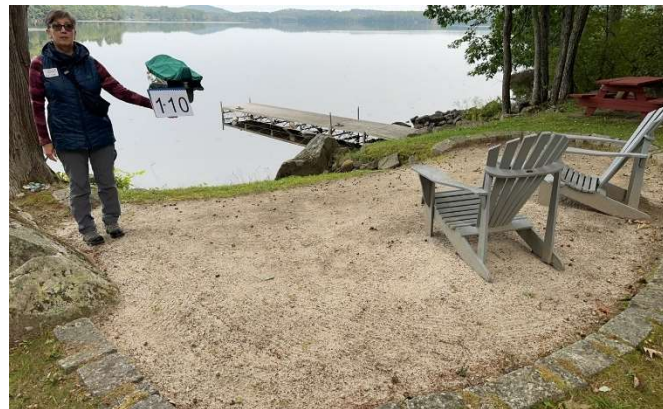
*Medium impact erosion site 1-10 off Bellefonda Road.*

Recommendation(s): Establish native shoreline buffer vegetation and define a narrow access point to the water (less than 4-6' wide). Additional plantings could boarder seating area and would

help capture additional runoff – especially if planted immediately up slope of the seating area.

Cover bare soil with erosion control mulch (ECM), clean  $\frac{3}{4}$ " crushed stone with or without pavers, or other stable and permeable surface material that will cover and protect soil and prevent future erosion. Both practices, the planting and covering of soil will slow runoff velocity and allow water to infiltrate into the soil before entering Pocasset Lake.

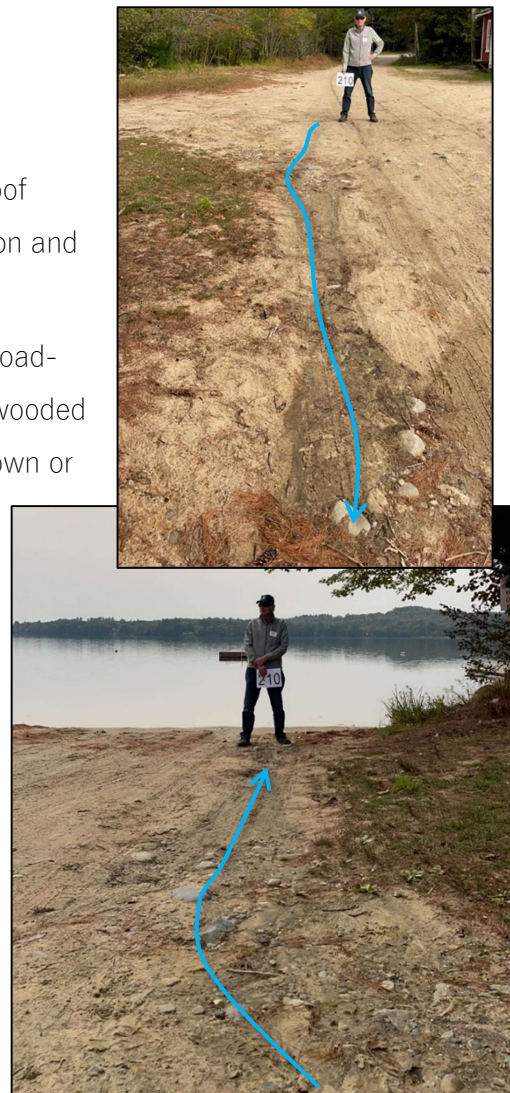
*High impact erosion site 2-10 at Richardson's Beach.*

Recommendations: Install runoff diverter (water bar, broad-based dip, rubber razor, etc.) to deliver runoff into the wooded buffer along each side of the road, and/or reshape (crown or super elevate) the road to move runoff off of the road surface as quickly as possible. To address the roof runoff erosion, landowner is actively working on improvements to the existing gutter system with an outlet into the low-lying area behind the building. It is highly recommended that any outlets deliver runoff into vegetation where it can be infiltrated, and not directly to any surface waters. Contact 30 Mile for a free site visit and comprehensive site plan.

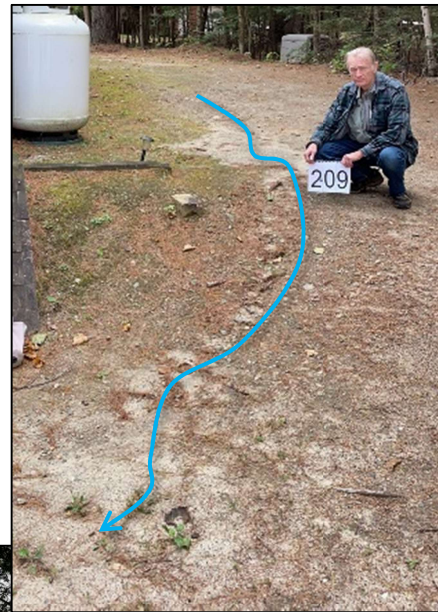
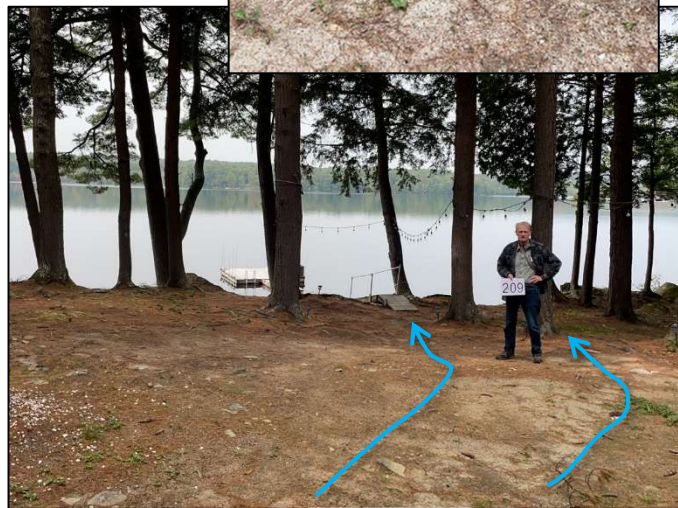
Site Number(s): 2-09

*High impact erosion site 2-09 located on a residential property*

Recommendation(s): Establish understory buffer vegetation through native plantings, and allowing the area between the shoreline and the building to revegetate or encourage new growth by reseeding with conservations seed mix. Define and then stabilize narrow footpaths with erosion control mulch (ECM) or  $\frac{3}{4}$ " clean crushed stone, and install waterbars along the path. Install an infiltration trench underneath roof dripline to infiltrate runoff and prevent erosion. Address runoff on driveway by installing rain garden at driveway end to capture runoff or install runoff diverters (rubber razor blade or broad-based dips) to deliver runoff into adjacent stable, wooded areas where runoff can be treated away from the lake.

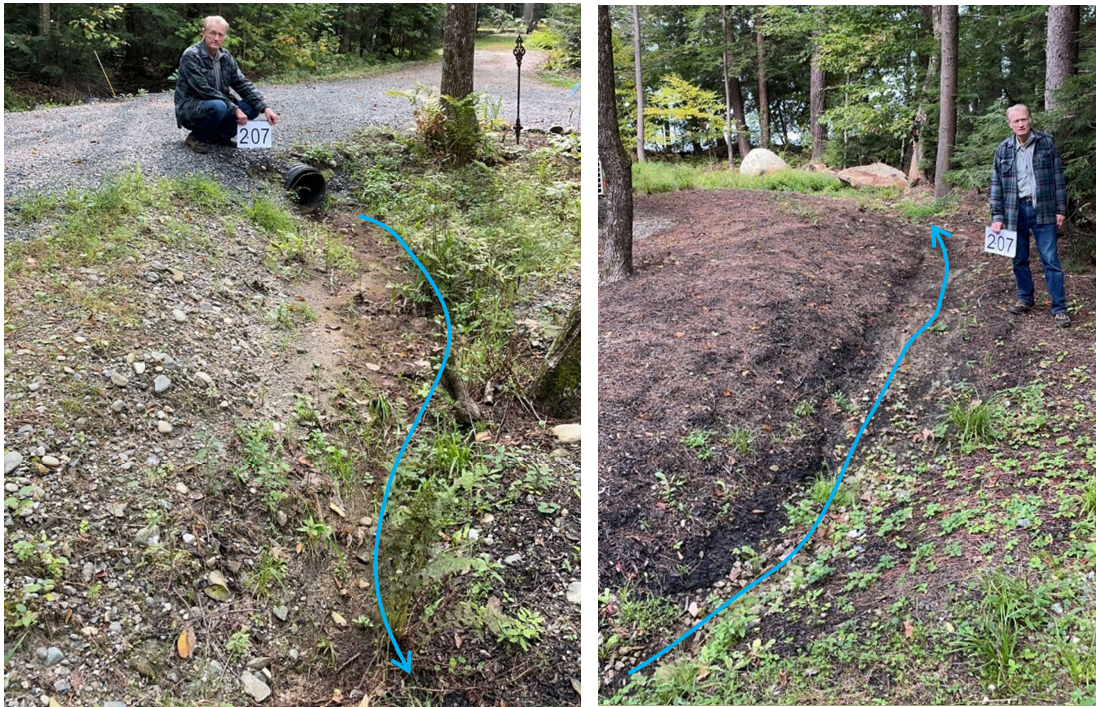
*High impact erosion site 2-09 at a residential property with surface erosion (rill) and bare soil on a driveway leading down to water access.*

Recommendations: Re-seed and armor the culvert outlet with angular stone (~4-6" riprap) to help hold the soil to the bank. Install a plunge pool/infiltration basin at the culvert outlet, lined with same angular stone riprap over non-woven geotextile fabric (contact 30 Mile to purchase at cost). Line

center of swale with crushed rock and direct flow into wooded buffer area. Allow entire eroded area to revegetate naturally and jumpstart growth by over seeding with conservation or contractor seed mix (typically available at your local farmers union).

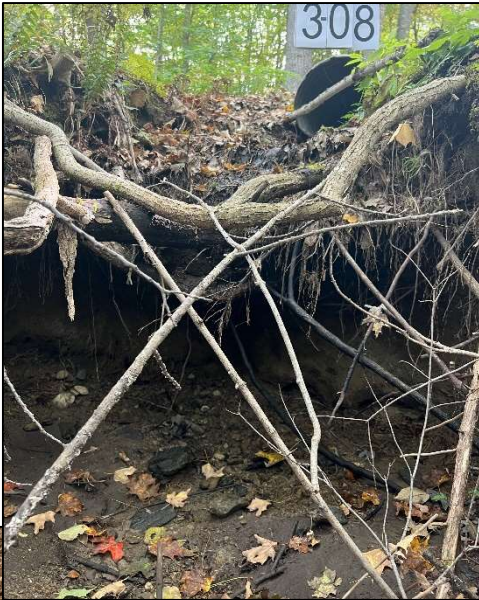
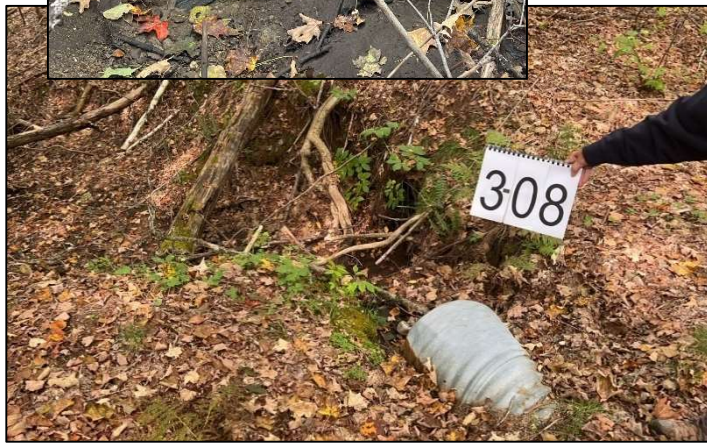
Site Number: 3-08

*High impact erosion site 3-08 on the White Road in North Wayne.*

*The culvert outlet is severely washed out with failing banks posing a large threat to public safety and water quality.*

Recommendation(s): Assess upstream drainage area

and replace with a new and larger culvert – armored at both ends with angular stone (aka riprap). It is likely that the culvert needs to be realigned and reset at a different elevation. Install a plunge/sediment pool and/or level-lip spreader or riprap apron at the culvert outlet to armor the downstream road bank.

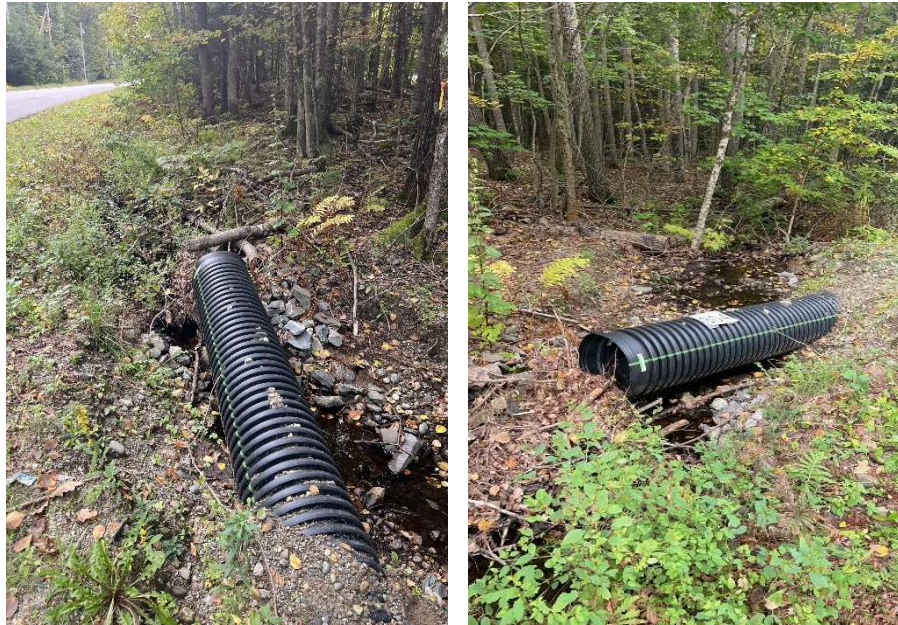
Problem(s): Snowmobile trail cross-culvert in stream/ditch line has failed, likely due to misalignment and improper sizing. Stream and ditch flow north to bottom of hill on N. Wayne Road and outlet into a tributary to Pickerel Pond.

*High impact erosion site 3-04 on N. Wayne Road in North Wayne. Snowmobile trail cross-culvert failure.*

Recommendation(s): Replace culvert with proper sizing and alignment. May consider removing culvert completely and installing a bridge structure instead. A thorough investigation of upstream

sources of flow and drainage area assessment recommended. Ditch turnouts installed along the ditch line uphill of this sight could help reduce volume and velocity of flow at bottom of hillside.

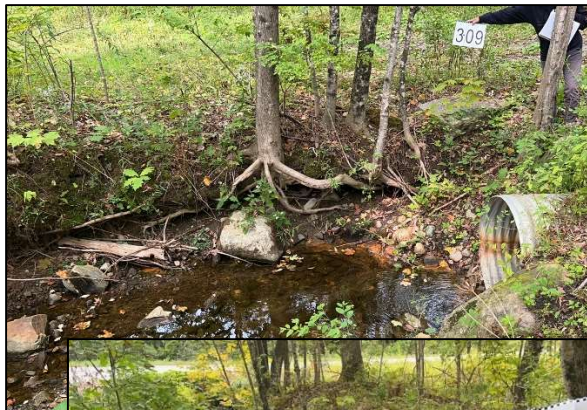
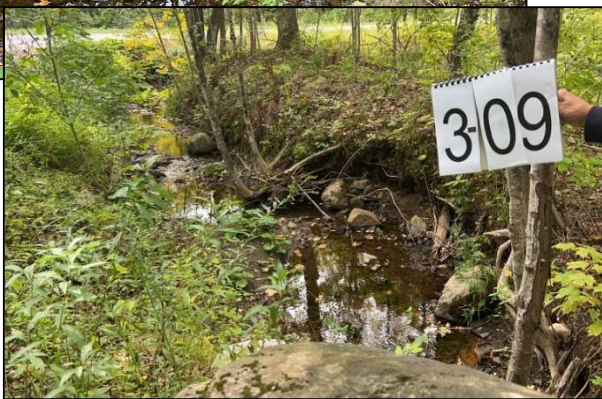
Site Number: 3-09

Problem(s): Unstable culvert inlet/outlet, surface erosion, and bank failure downstream of culvert.

Recommendation(s): Enlarge and realign culvert. Armor culvert inlet/outlet with angular stone. Streambank stabilization needed on downstream banks potentially from high-velocity flow from culvert hitting the downstream bank. Extend armoring to cover bank at culvert outlet and add live stakes throughout

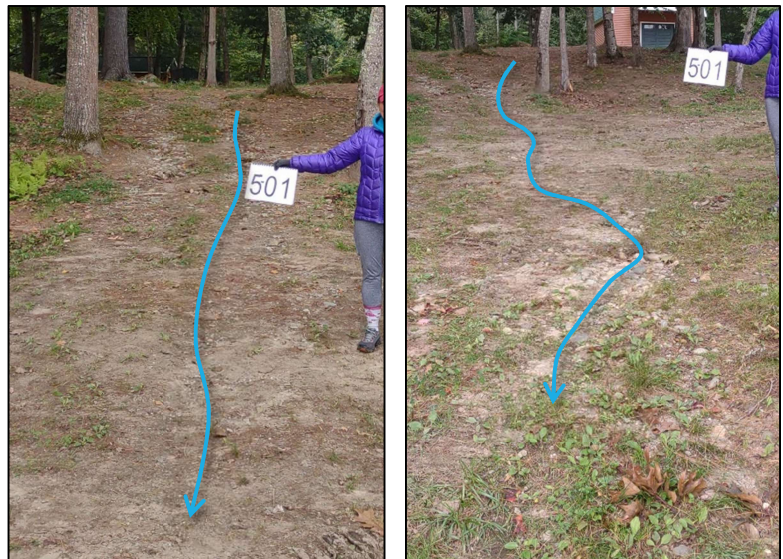
*High impact erosion site 5-01 with surface erosion and bare soil.*

Recommendation(s): Define a narrow and meandering pathway to the water and stabilize with erosion control mulch (ECM) or clean  $\frac{3}{4}$ " crushed stone. Install runoff diverters (waterbars) above and along walking paths to prevent runoff flow downhill toward the lake and instead direct runoff into a stable, vegetated areas. Do not rake leaves or needles. Revegetate bare soil and/or reseed thinning grass. Consider establishing planted areas in naturally existing low spots to help slow and infiltrate runoff.

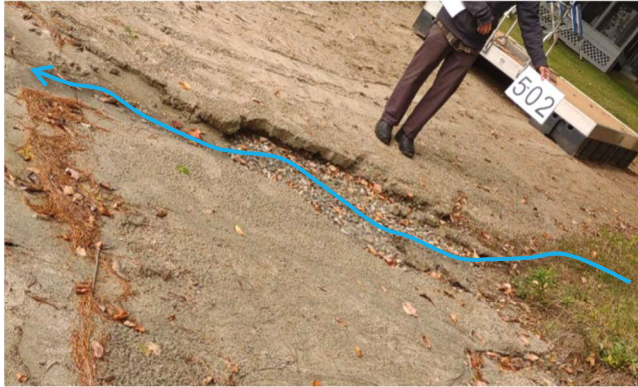
Site Number: 5-02

*Medium impact erosion site 5-02 where runoff has caused gully erosion on a residential beach access.*

Recommendation(s): Install runoff diverters (waterbars or similar) above the beach to break up flow and redirect it into stable areas

where it can be absorbed/treated away from the lake. Install a rain garden to create a stable area to receive flow if needed. Create a vegetated buffer area behind the beach to add a perimeter buffer that will capture and infiltrate additional runoff flowing toward beach and lake.

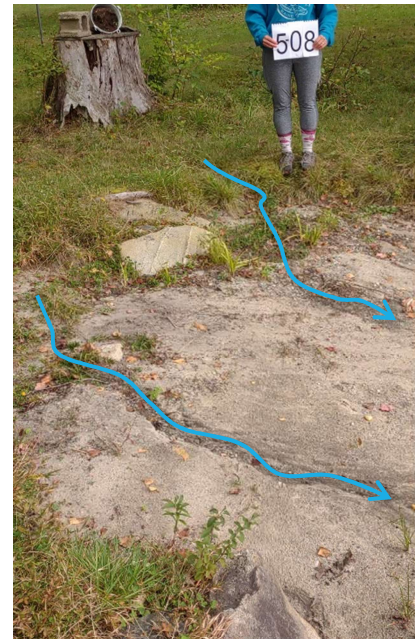
*Medium impact erosion site 5-08 where runoff has caused gully erosion on a residential beach access.*

Recommendation(s): Define a stable footpath and water access point (no more than 4-6 ft wide). Vegetate the remaining shoreline surrounding the defined access point by installing native plantings throughout to improve/establish a shoreline buffer zone and stabilize shoreline soils.

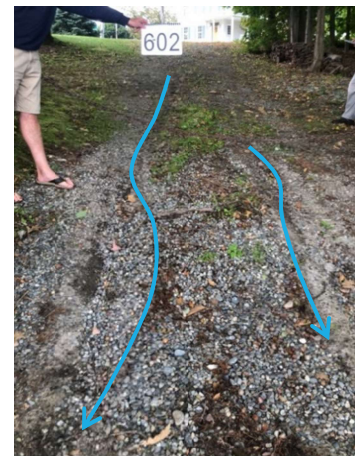
*Medium impact erosion site 6-02 on a residential boat access.*

Recommendation(s): Install two runoff diverters (rubber razor or water bar) across boat launch to redirect flow into stable wooded areas where it can be absorbed and treated away from the lake.

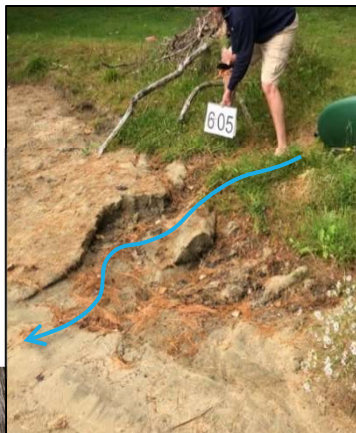
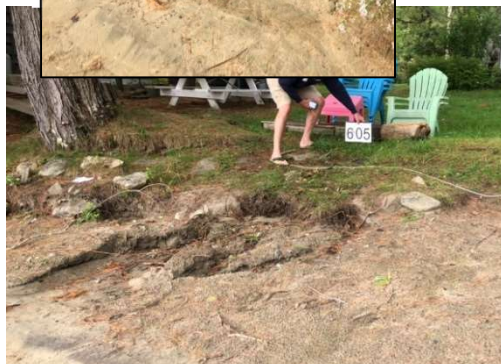
Site Number: 6-05

*Medium impact erosion site 6-05 with beach shoreline erosion on a residential property.*

Recommendation(s): Reduce the amount of runoff exiting developed spaces by installing an infiltration trench at roof driplines. Install a rain garden, infiltration trench, or diversion at the end of the driveway to help capture or divert driveway runoff to a stable area where it can be treated away from the lake. Add native plantings to the shoreline buffer and consider establishing a rain garden in low spots where water is running around/over the shoreline berm and causing erosion.

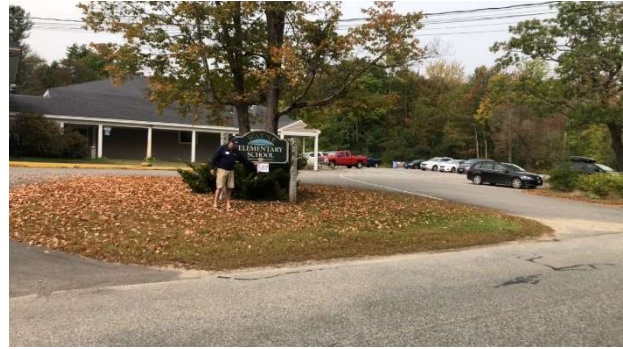
*Medium impact erosion site 6-07 has large areas of impervious surfaces that deliver surface runoff across Pond Road toward Pocasset Lake.*

Recommendation(s): Reduce runoff from roofs, parking areas, and driveways by installing rain barrels or drywells at gutter downspouts. Install additional ditches, infiltration swales, and grated culverts to capture runoff from paved surfaces and reduce export of runoff across the street.

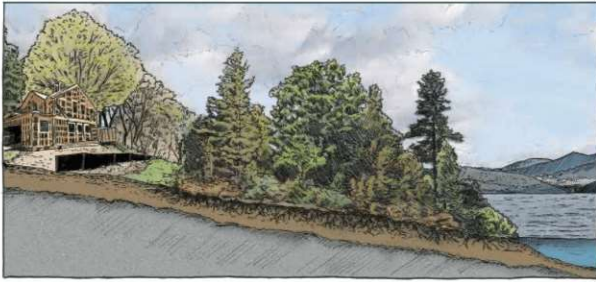
1 73% of stormwater runoff infiltrated by grass lawn and 100-foot wide buffer.

2 58% of stormwater runoff infiltrated by grass lawn and 50-foot wide buffer.

Remember, trees do not live forever. It is important to nurture the next generation of big trees on your shoreline by allowing some of the saplings in the buffer understory to grow and mature. One day, these will take the place of the larger trees currently growing on your lake front.
