# Parker Pond Watershed-Based Protection Plan 2018

Prepared by:  
30 Mile River Watershed Association  
April 2018

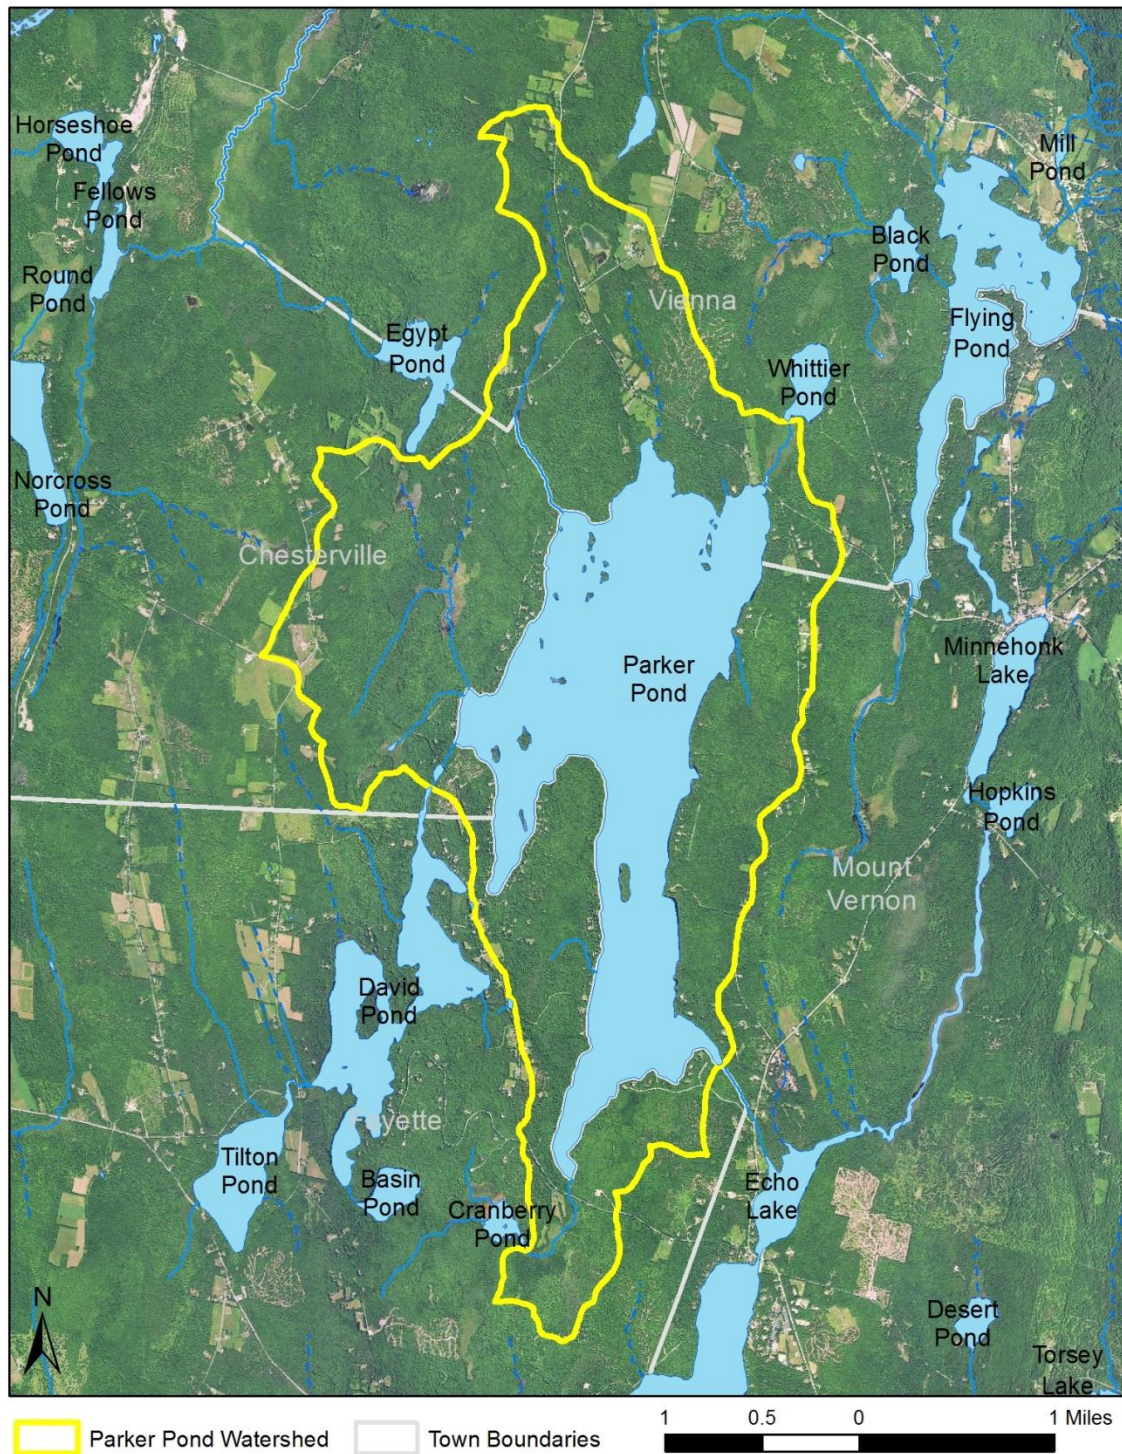
**Summary Figure 1:** The Parker Pond Watershed spans across Chesterville, Fayette, Mount Vernon, and Vienna, Maine.

***Location and Physical Characteristics:*** Parker Pond is a 1524-acre waterbody within the 30 Mile River Watershed in Central Maine, northwest of Augusta, spreading across the four towns of Chesterville, Fayette, Mount Vernon, and Vienna in Franklin and Kennebec Counties (Figure 1). The lake has a direct watershed of 6.3 square miles, an average depth of 31 feet, a flushing rate of 0.3 times/year, and above average water quality with moderate dissolved oxygen depletion in deep areas. In 2018 the MDEP placed Parker on its list of *Nonpoint Source Priority Watersheds* due to sediment chemistry (described in “Threatened Status” below). Parker has no known invasive aquatic plant infestations.

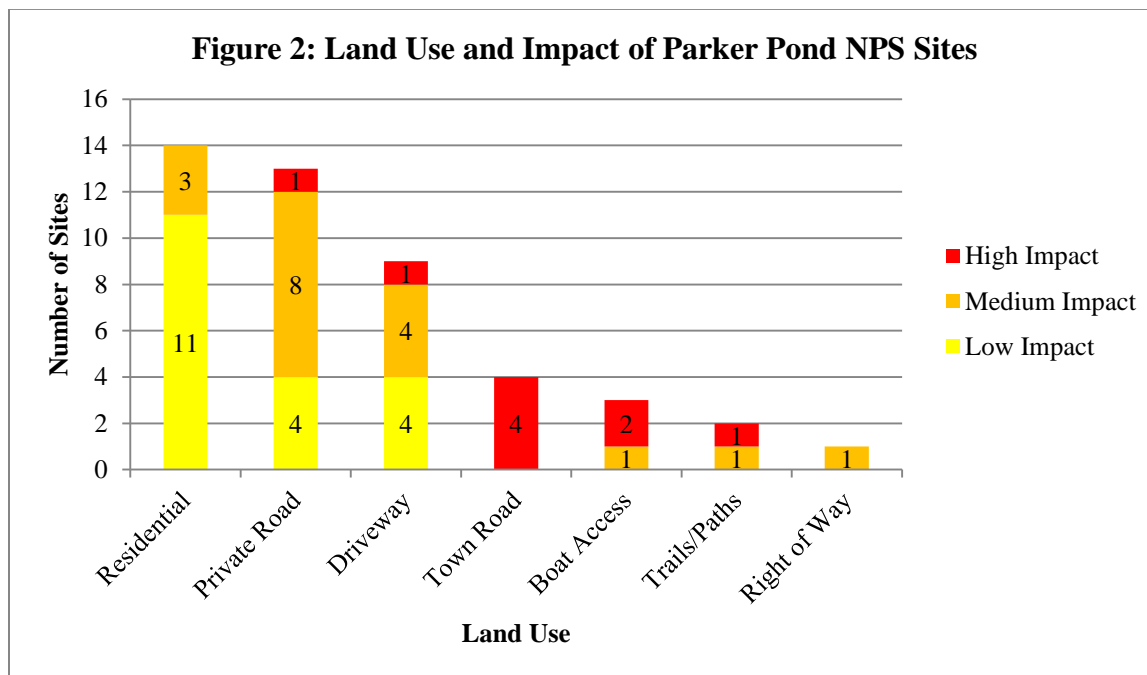
*Data from the 2011 Watershed Survey*

Twenty-seven of these 46 total sites were identified as high or medium impact, due to site size, slope, amount of soil eroded, and proximity to the water. The greatest problems were associated with residential properties (14), private roads (13), and driveways (9). The remaining problems were associated with town roads (4), boat accesses (3), trails/paths (2), and right of way (1). Aside from soil erosion, no other significant sources of phosphorus were observed during the survey.

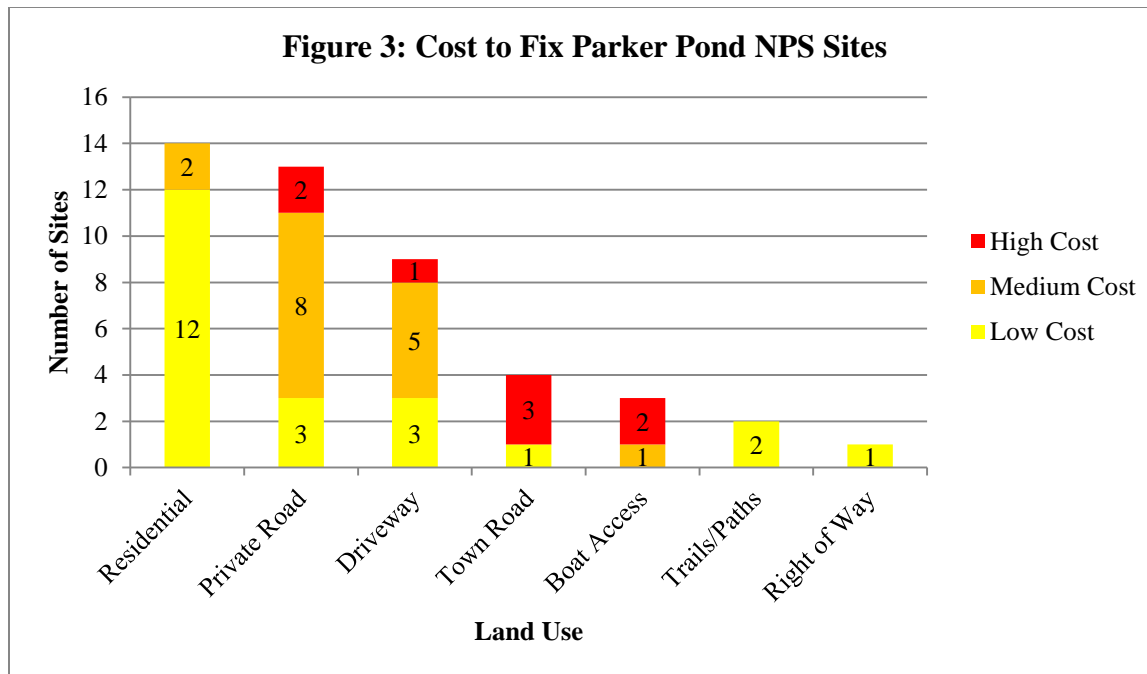
Data from the 2011 Watershed Survey
